March 21-24, 2025

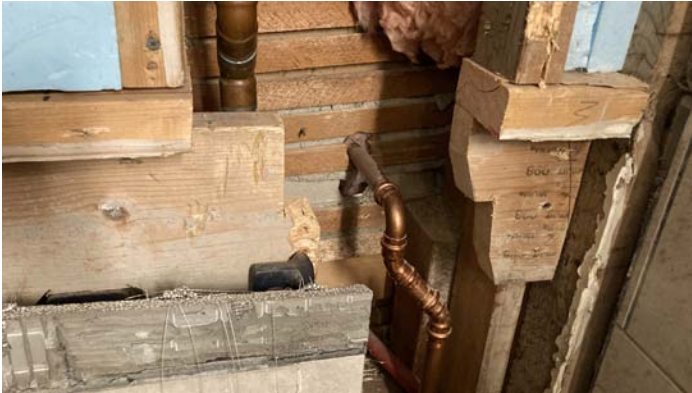
BathStructureBefore.JPG

Wall structure behind 2nd window seat was cut for the emergency plumbing repairs during the winter leak of 2023. Repairing the wall structure was the first step of repairs here. Glued and screwed plywood sandwich over torsionally braced 2x6.

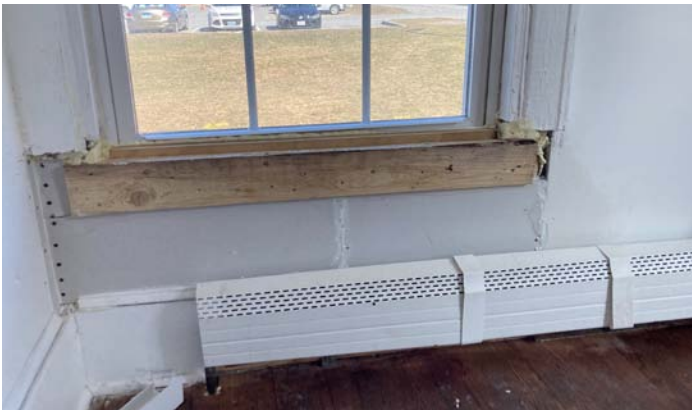
BackRamWindow_1899.JPG

Back Ram as left by the insurance contractors.

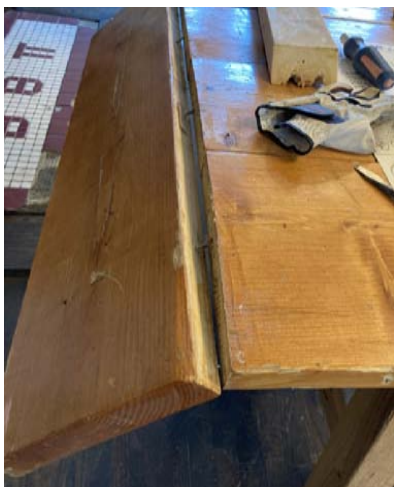
DR_Table_1901.JPG

Random house conditions.
