# May Trip #1 2025

## DR\_Drainage\_Grading Hancock Side/water issues in Pine room

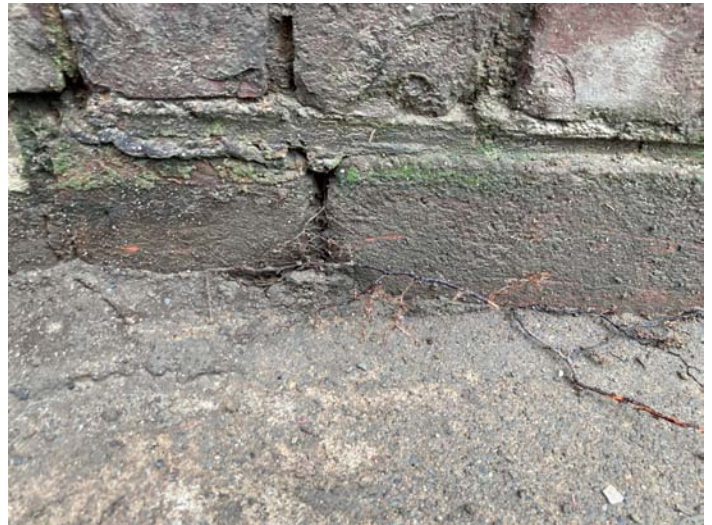
DRside\_DrainagePlane\_2101.JPG  
Mortar detail

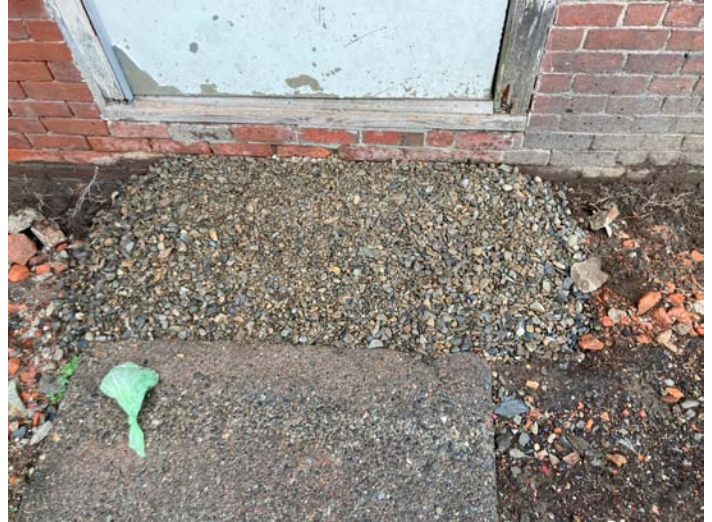
DRside\_DrainagePlane\_93.JPG

Deteriorating concrete landing removed,  
French Drain Stone elevation set.  
Pad can be replaced/repoured after  
mortar repair completed.

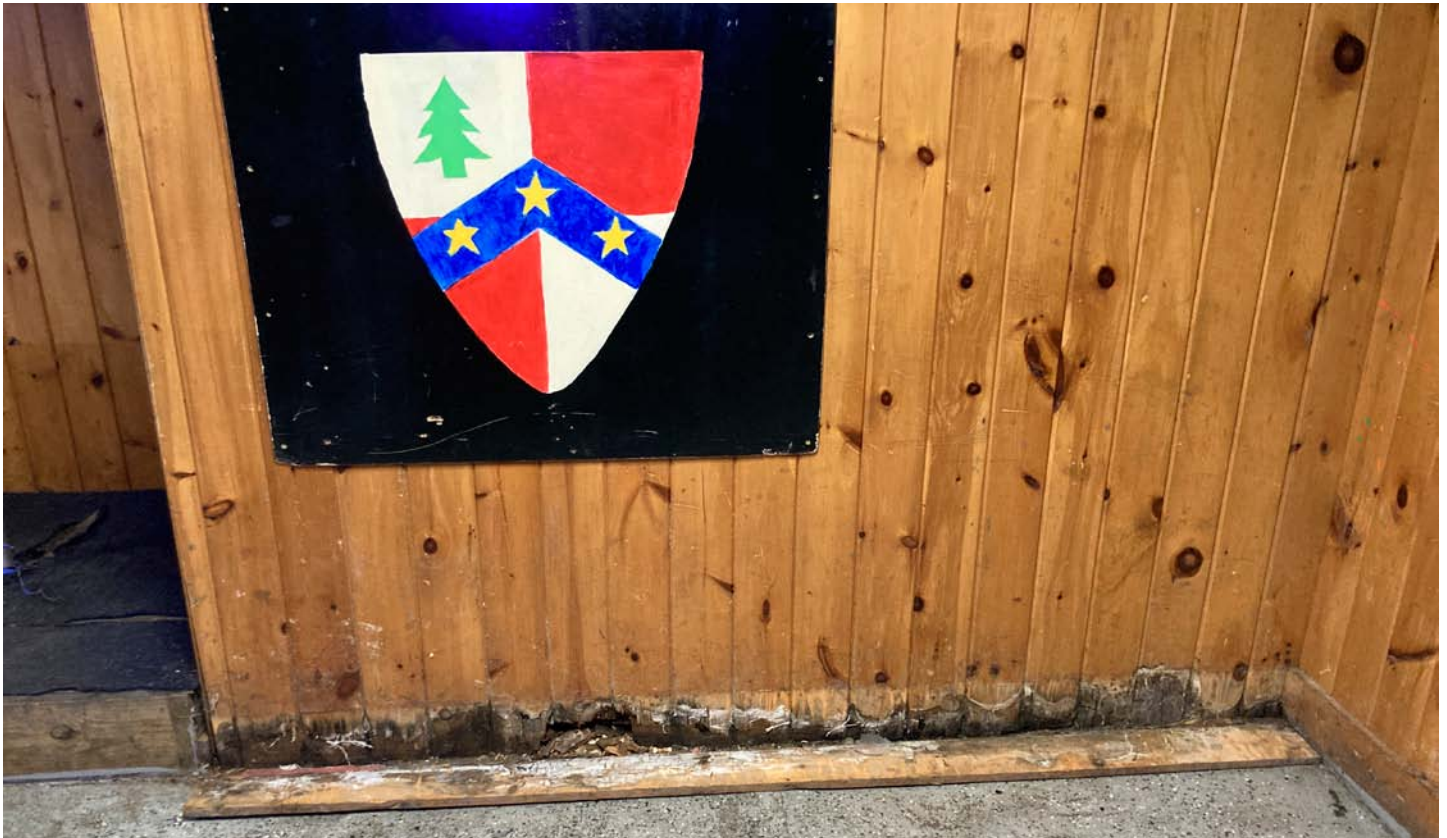
**[PineRoomWallRot\\_2053.MOV](#)**

**Rot at bottom 5 inches of wall is visible  
throughout the Pine Room.**
