Project Report:

Building outside condition June 16-17

July 1-3, Stage 1 new drip edge installed; Stage 2, July 15-25

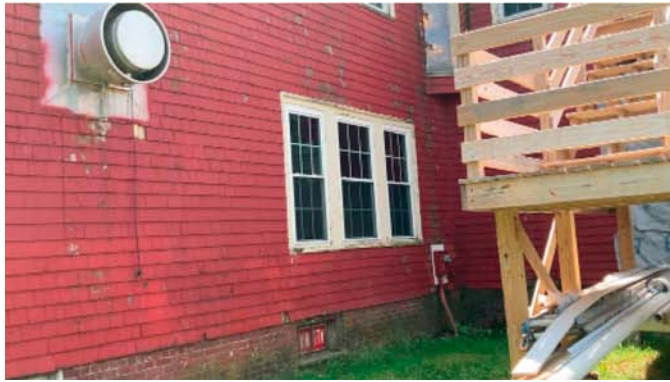
[617-4 KITCHEN WALL 2441.MOV](#)

There is water intrusion gap at top of kitchen exhaust hood. The technical term for this back wall is "super sketchy."

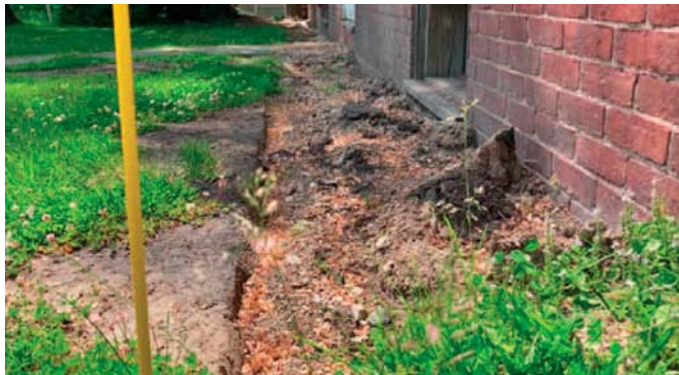
[617-10 GradePitchSEFoundation2450.MOV](#)

Loam backfill by UMO a few years ago ended up being 3-4 bricks too high on back side, keeping bricks in contact with soil and surface moisture which leads to mortar degradation over time. These bricks should not be below grade.

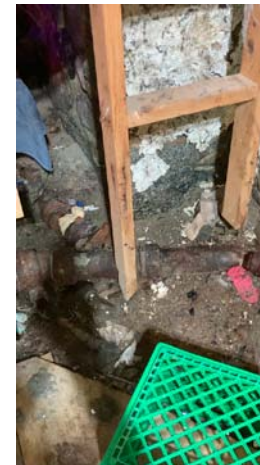
Corroded hose pipe section of galvanized iron that should be the last piece in the house. Such pipe was abandoned in the 1960's in favor of copper. (Replaced with copper and freeze-proof outdoor faucet by Kennebec Plumbing)

Bad news about the leak is that it was in the center of the 18" wide brick foundation and dripping for who-knows-how-long any time the hose supply valve was turned on.

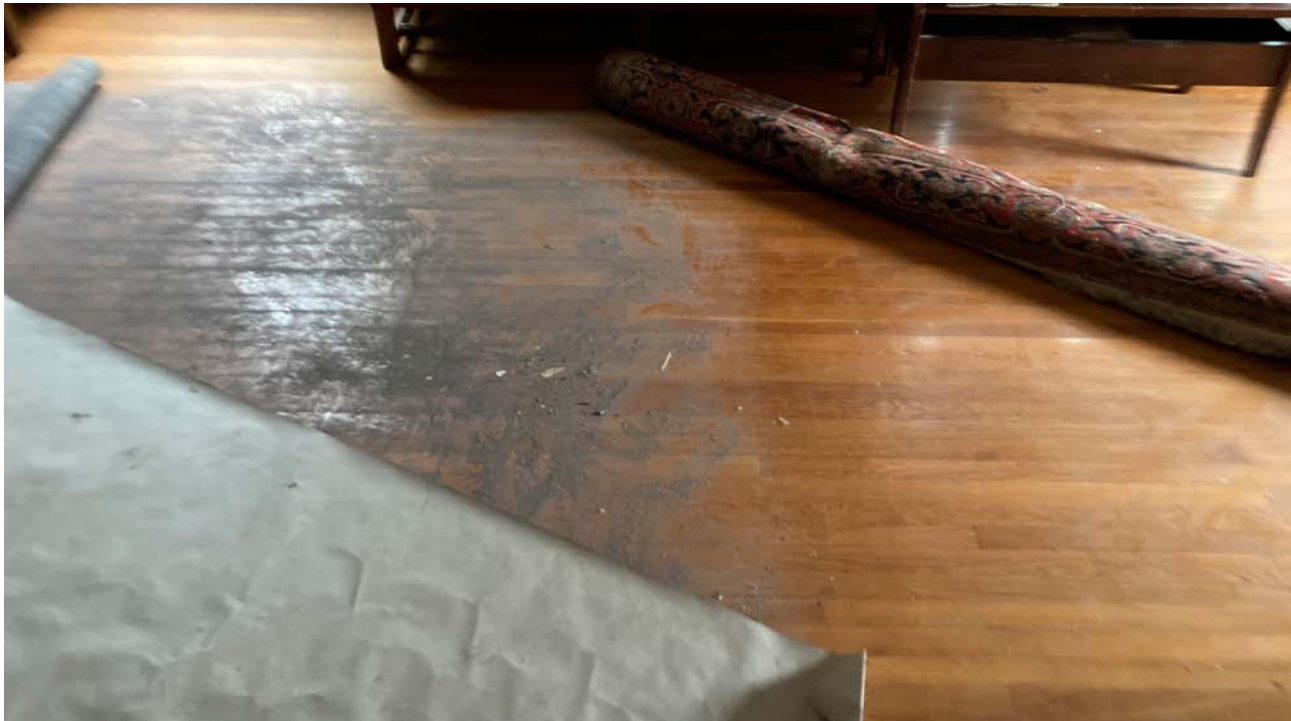
At left, mostly fine dust from deteriorating rug pad. At right, pad was discarded and floor cleaned in July of 2021 and appears here as I left it then.

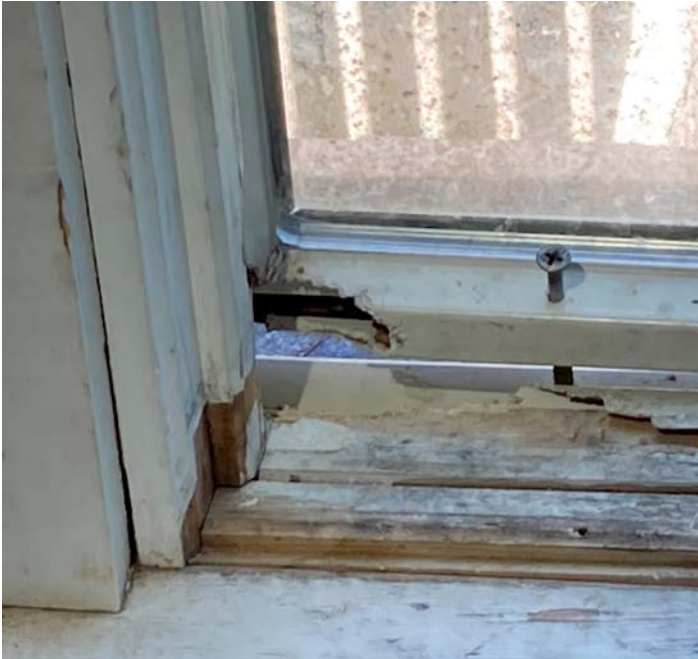
725-6-RamWindowTrim_2660.JPG

Picture window side vents damaged & hardware missing. Drywall screws used to hold windows closed. Animal chew marks on window frame and trim. Trying to get inn or out?
