# May Trip #1 2025

## DR\_Drainage\_Grading Hancock Side/water issues in Pine room

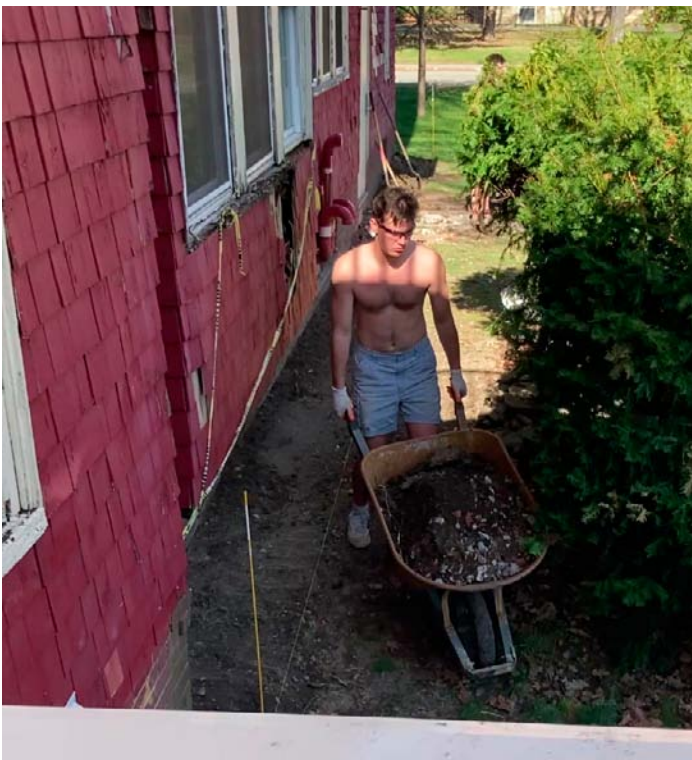
Jonah Harper leads the charge: out with the old!

Deteriorating concrete landing removed,  
French Drain Stone elevation set.  
Pad can be replaced/repoured after  
mortar repair completed.

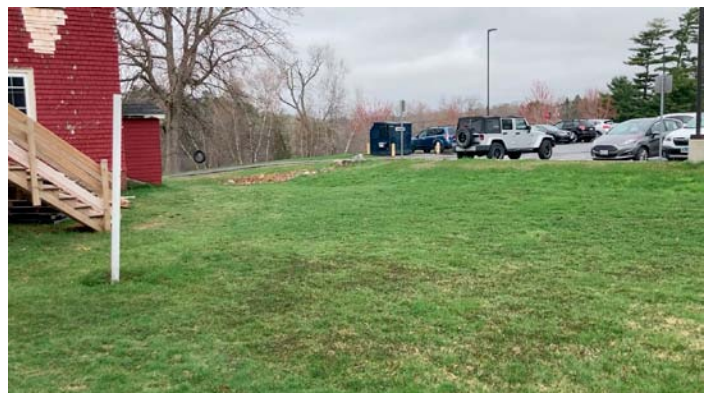
**AlfondSide\_DrainagePlane\_2116.MOV**

**Cellar wide humidity issues with water pooling/intrusion;  
lack of ventilation/air circulation.**
