Project Report:

Building outside condition June 16-17

July 1-3, Stage 1 new drip edge installed; Stage 2, July 15-25

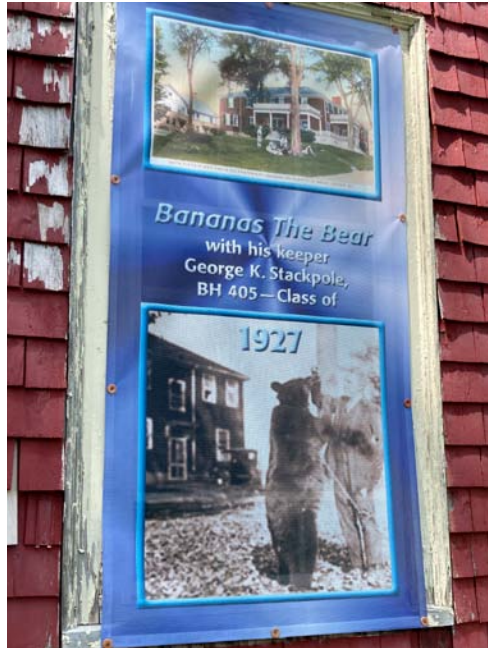
617-11_GoodwillBanner2452.JPG

Banners for University community promote goodwill and emphasize our long connection to UMO and that the House is damn old! (Also hides messes in street-level Back Ram rooms during summer.)

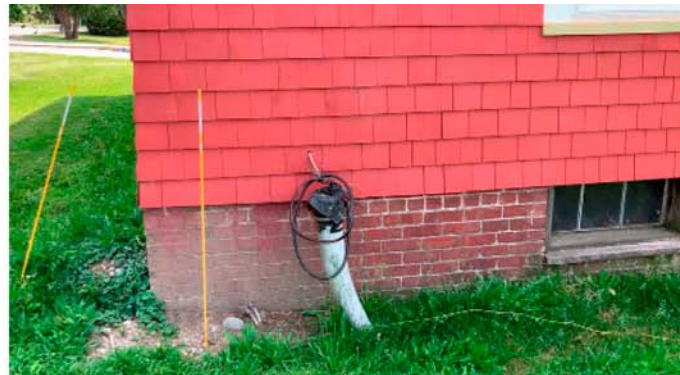
[617-5 GradePitchNEFoundation2442.MOV](#)

Loam backfill by UMO a few years ago ended up being 3-4 bricks too high on back side, keeping bricks in contact with soil and surface moisture which leads to mortar degradation over time. These bricks should not be below grade.
